Project Name	Project Number	Project Date 24/05/2021

Company: Developer Services, Southern Water
Department: Southern House
Street: Yeoman Road
Town or City: Worthing
County: West Sussex
Post Code: BN13 3NX

Section 1	Inspection 1	Date 24/05/21	Time 10:07	Client's Job Ref	Weather No Rain Or Snow	Pre Cleaned No	PLR IC1X
Operator		Vehicle -		Camera -	Preset Length 0.00 m	Legal Status -	Alternative ID -

Town or Village:	Fareham	Inspection Direction:	Downstream	Upstream Node:	IC1
Road:		Inspected Length:	54.85 m	Upstream Pipe Depth:	
Location:		Total Length:	54.85 m	Downstream Node:	SU57067301
Surface Type:		Joint Length:	0.00 m	Downstream Pipe Depth:	
Use:	Foul	Pipe Shape:	Circular		
Type of Pipe:	-	Dia/Height:	100 mm		
Year Constructed:		Pipe Material:	Vitrified clay pipe (i.e. all clayware)		
Flow Control:	-	Lining Type:	No Lining		
Inspection Purpose:	Condition and location	Lining Material:	No Lining

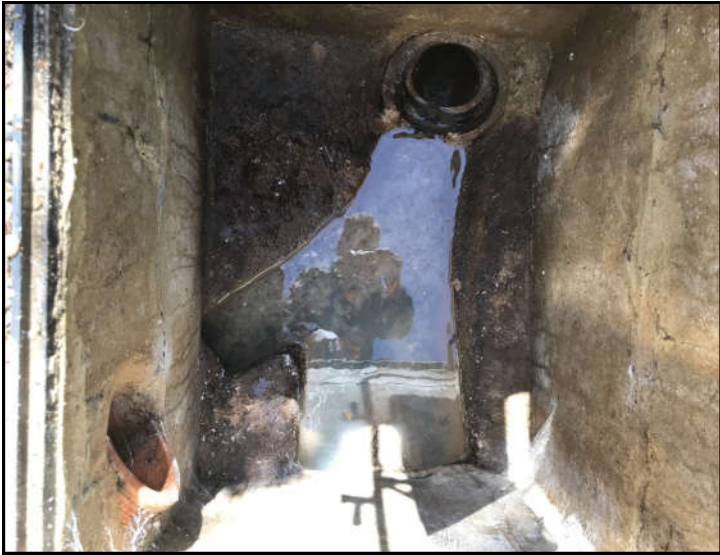
IC1 - BLOCKED AT TIME OF SURVEY

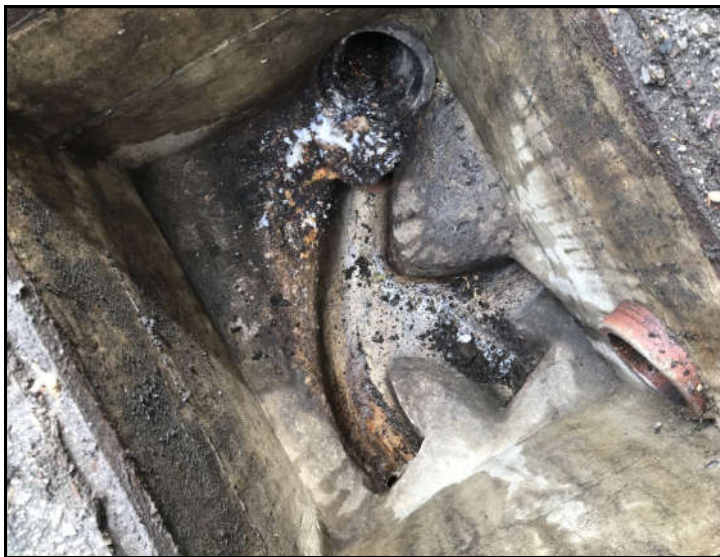
IC2 - PRIVATE MH

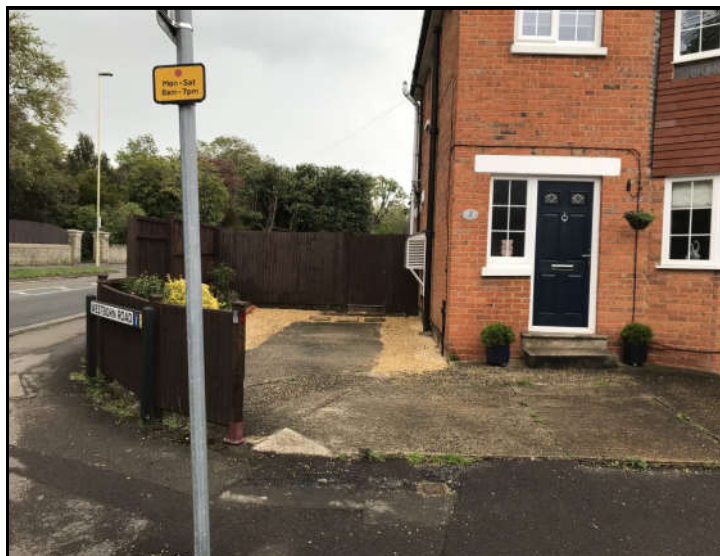
SU57067403.
UNABLE TO LOCATE / LIFT AT TIME OF SURVEY

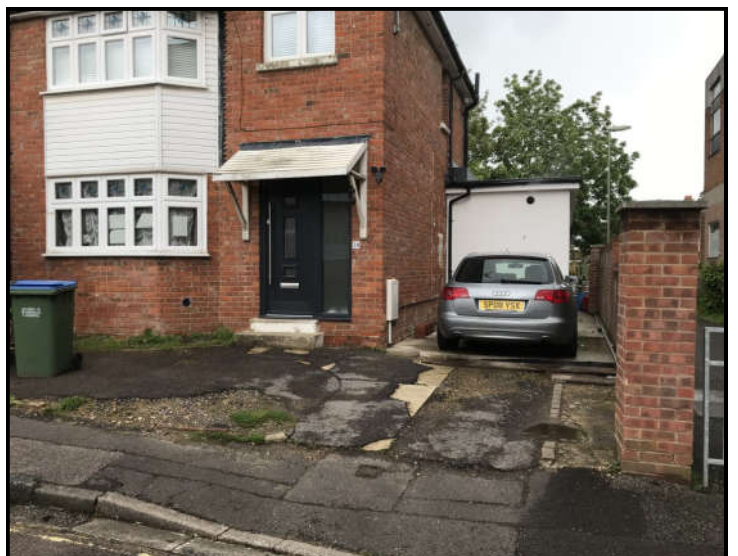
SU57067301.
UNABLE TO LOCATE / LIFT AT TIME OF SURVEY

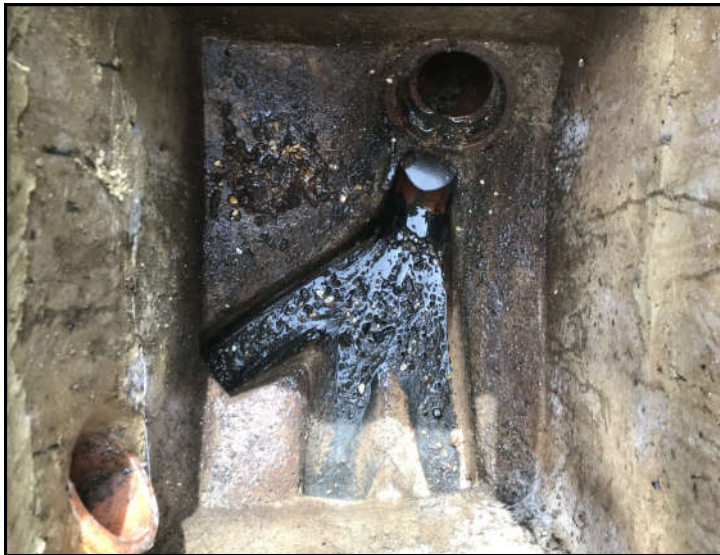
IC1 - CLEARED AT TIME OF SURVEY

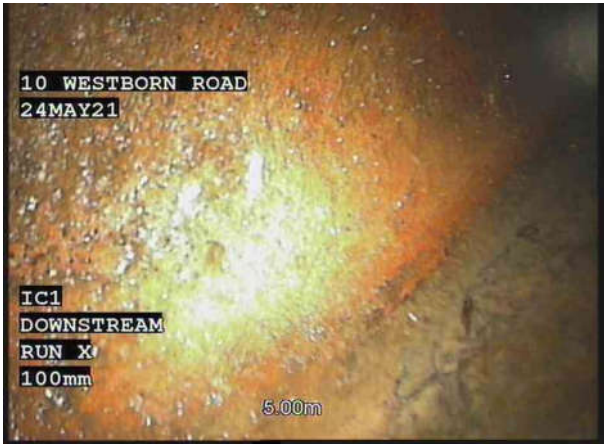
1, 00:00:47, 5.00 m
General remark, At saddle connection

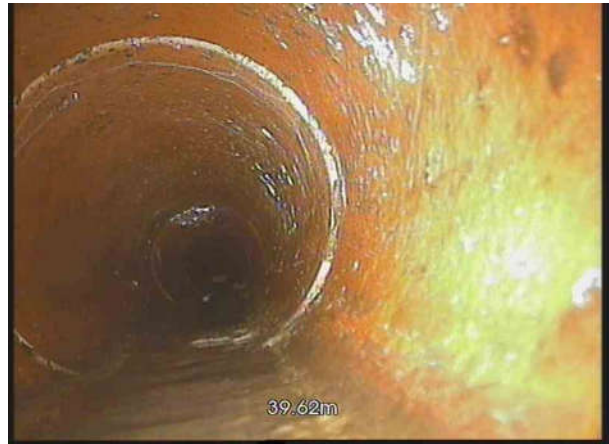
2, 00:03:30, 39.62 m
Crack, circumferential at joint from 10 o'clock to 02 o'clock

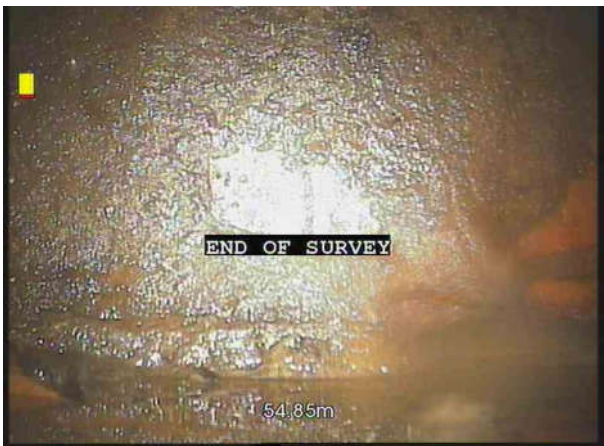
3, 00:05:24, 54.85 m
Finish node type, manhole, reference number: SU57067301,
Unable to locate / lift
